Boat fire at a marina dock

Sunday morning, November 5, 2023

This report covers a fire that destroyed one boat and damaged another. The boats were in a marina in Maine. Loss or significant damage to several other boats was averted due to the unusually fast response of the local volunteer fire department. There are several important observations and lessons learned from this incident.

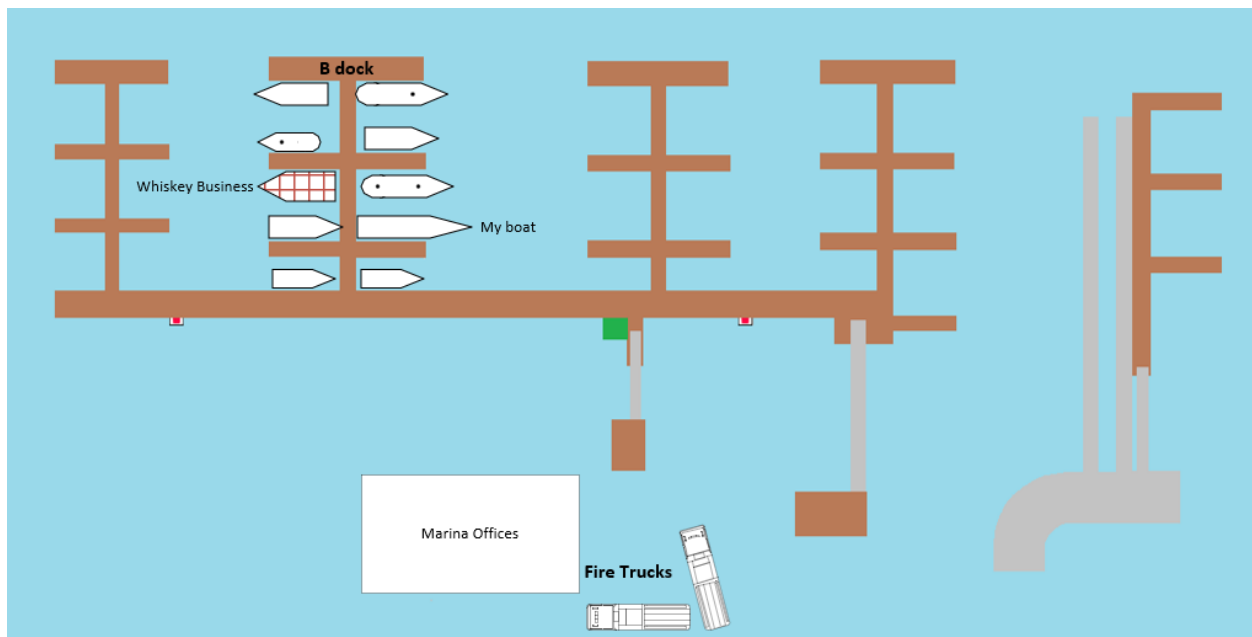
Figure 1 - Boats on "B" dock Sunday morning. Fire trucks arrive about 0915.

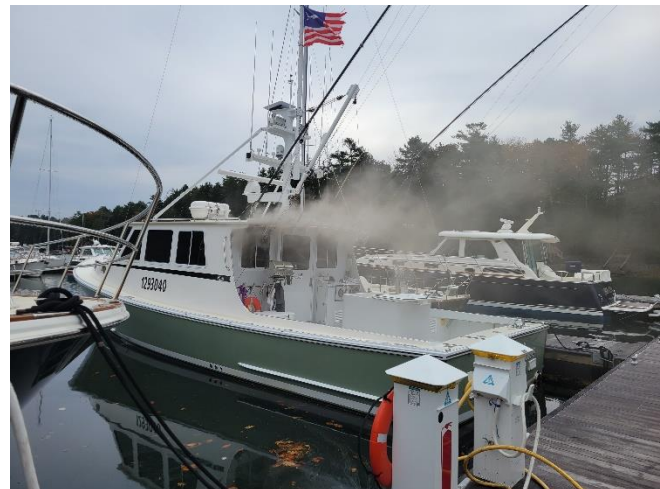
0911: Smoke was streaming from the partially open window (aft port corner of the main cabin) on Whiskey Business. The marina staff member and I discussed how we could move other boats away from Whiskey Business. Most boats were winterized, and we could not use their engines. We planned to untie them and push them out into the fairway away from the fire.

Figure 2 - Smoke from Whiskey Business at 0911

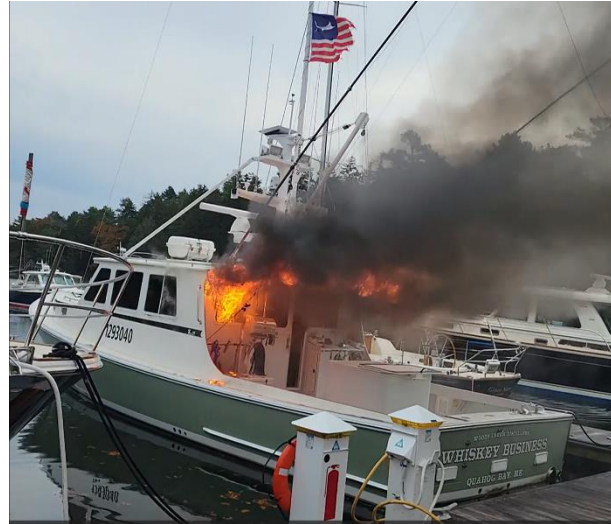
0915 (about): Two fire trucks and crews arrived. Smoke was heavier and streamed across the dock. Flames were now 2 feet high and coming out of the aft windows of the salon that appear to have all shattered. The first fire fighter attempted to deploy a Fire TKO fire suppression tool (FST) in the salon. FST was provided by the marina. The FST did not activate due to operator error (see appendix).

Figure 3 - Whiskey Business about 0915

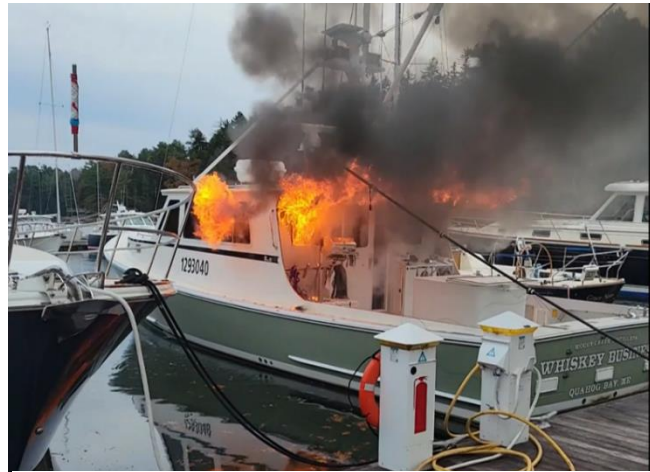
0918: Interior of cabin appeared fully engulfed in flame. Aftermost window on the port side of the salon shattered and flames rose several feet above the roof of the salon. Other windows started to shatter. Fiberglass outrigger fishing poles melted and fell. Flames reached the radar mast. Varnish started to blister on the boat adjacent Whiskey Business on port side. We made preparations to move adjacent boat. Ultimately the adjacent boat was not moved because the fire department arrived, and we decided the adjacent boat was no longer at risk of major damage.

Figure 4 - Whiskey Business at 0918

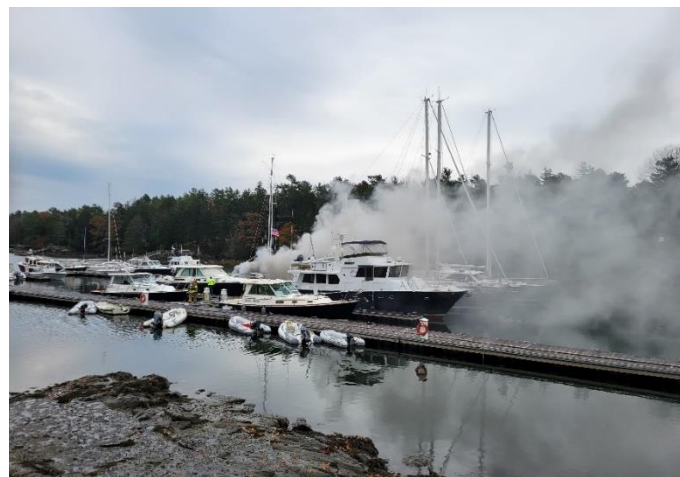
0923 (about): Fire department started fighting the fire with a 2 ½" fire hose that had been run down the docks to the scene. Flames were streaming out of the salon and across the aft deck of Whiskey Business. Most windows had shattered. Heavy smoke had engulfed the 5 boats around Whiskey Business. Only firefighters in protective gear with air tanks could approach Whiskey Business. All others evacuated from the dock.

Figure 5 - B dock at 0923. Note fire hose running down the dock.

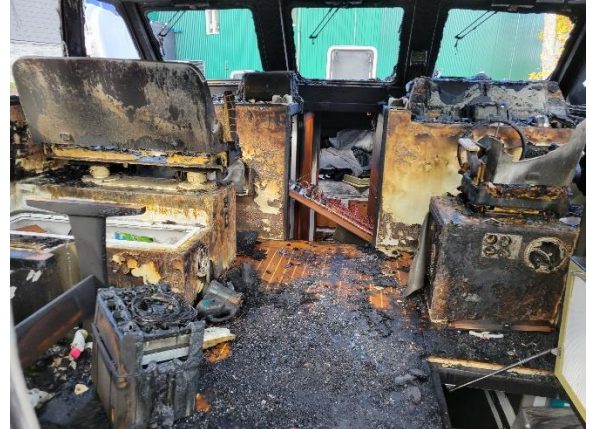
The source of the fire appears to have been a reverse cycle air conditioning unit located under a bench in the aft port corner of the main cabin. (Note this my personal observation and is not an official determination.)

Figure 6 - Interior of Whiskey Business

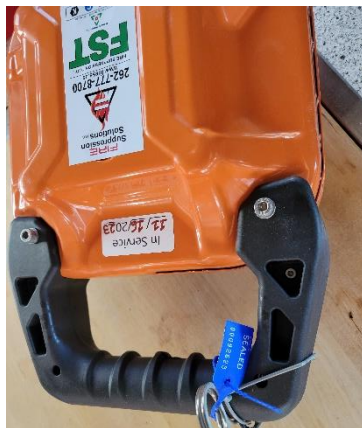
Pin #1 is large and very obvious. In this situation, that pin was pulled. However, pin #2 and its clip was small and the same color as the handle of the device. (Note that the clip for pin #2 is different in the new FST’s shown in the photo and is more obvious than the clip on the older FST’s we used.) It was not obvious that the clip was attached to a pin or that it needed to be pulled to activate the device. Pin #2 was not pulled and thus the device did not activate.

Figure 8 original metal pin #2

I have modified my FST by painting the clip for pin #2 yellow so that it is obvious and hopefully will be more obvious that pin #2 must be also removed to activate the device.

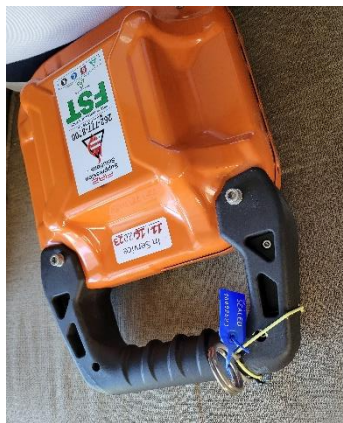
Figure 7 Pin #2 painted yellow
