# Magic Bus

Sank November 6, 2025 - all crew rescued

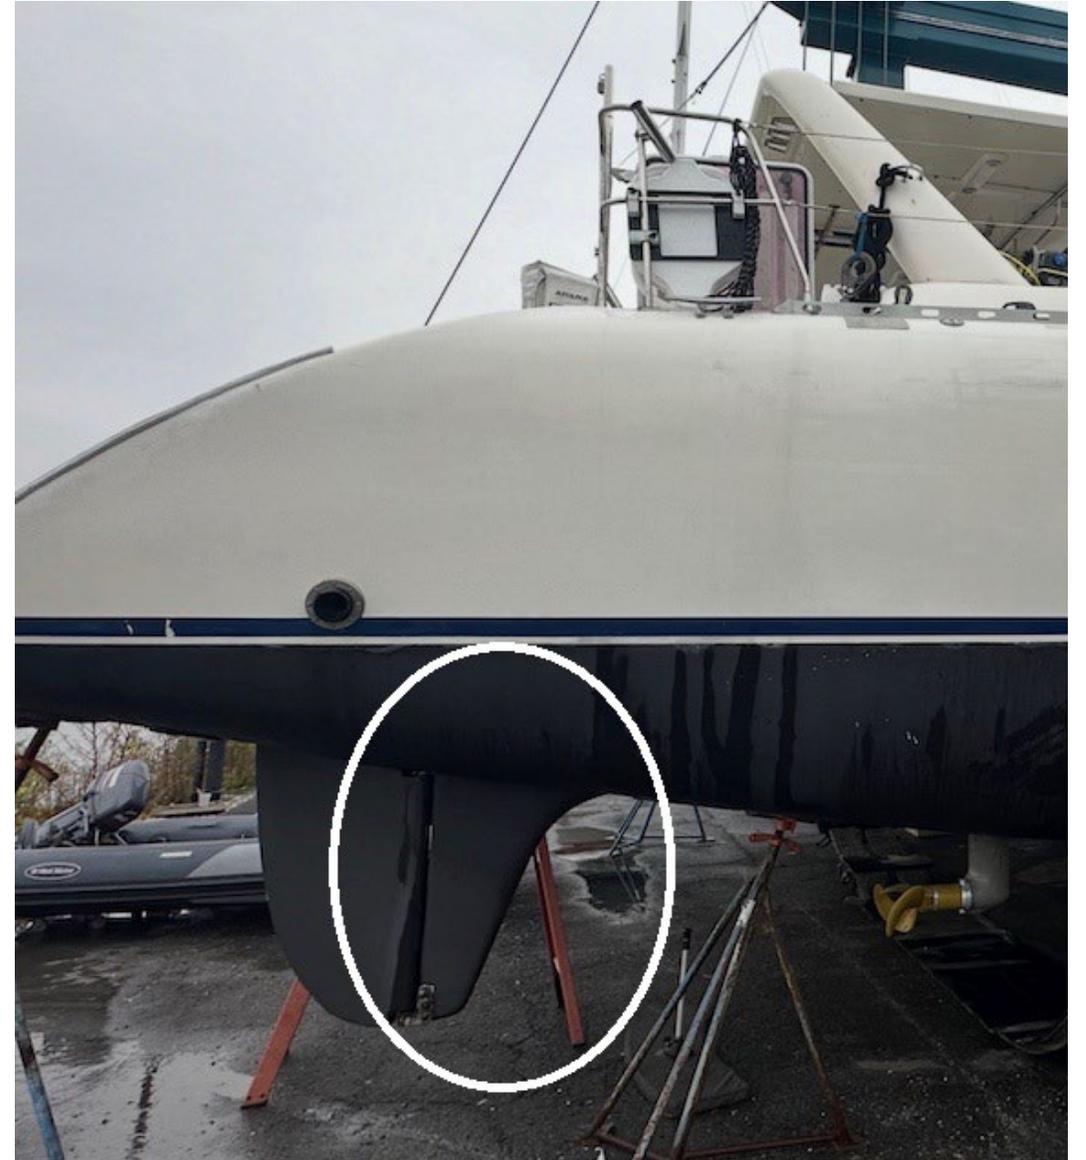
- 10 days later another boat saw the capsized hull. Photo showed the starboard rudder skeg had sheared off a couple inches from the hull.
- Hole was directly under the engine which is why it was not found.
