# Magic Bus

Sank November 6, 2025 - all crew rescued

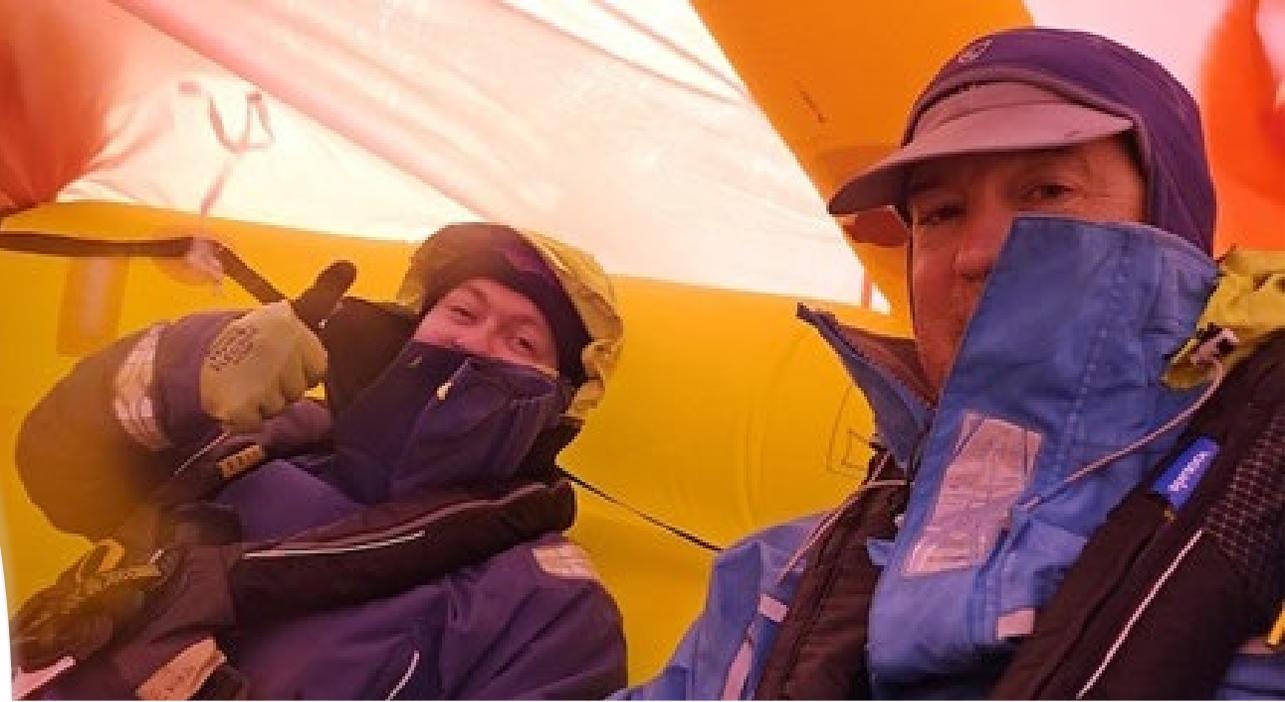
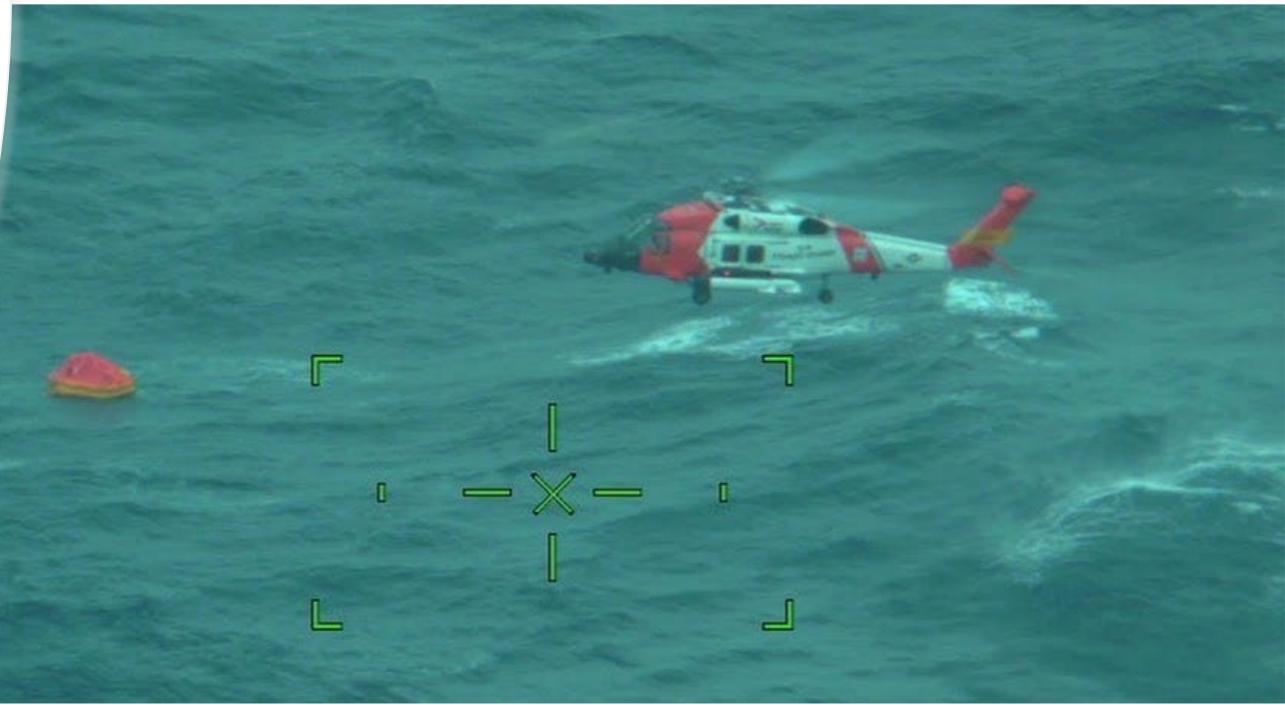
- Everyone quickly got seasick in the raft. Deploying the drogue helped greatly.
- 12-man raft so plenty of room.
- Plenty of food and water.
- Took Starlink mini with them, not used.
- Primary EPIRB and hand-held VHF did not work.
- SPOT handheld device worked.
- 0600 (about) USCG C-130 on station. Dropped support pack with line to raft. Pack had VHF radio. Comms established.
- 0800 USCG helo on station after refueling on diverted aircraft carrier.
